City of Boulder

# Pedestrian Crossing Treatment Installation Guidelines

November 2011

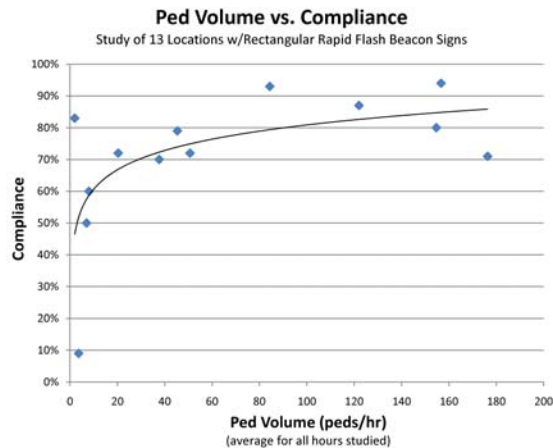
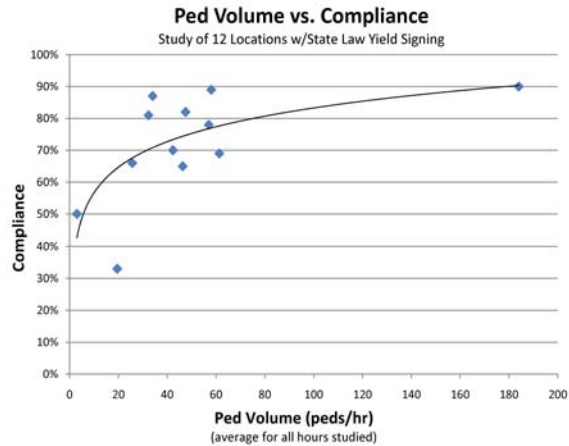
The City of Boulder has evaluated crosswalk enhancements at uncontrolled crossing locations over the years and has determined that there is a clear relationship between driver compliance (yielding) and the pedestrian and/or bicycle crossing volume. Data collected at Boulder crosswalks where rectangular rapid flash beacon signs (RRFB) or State Law-Yield signs were installed shows that driver compliance typically increases with higher crossing volumes. It is theorized that the primary reason for this relationship is that drivers tend to ignore enhanced crossing treatments over time at locations where they infrequently see pedestrians crossing. The following graphs illustrate this relationship:

The above data also illustrates that, below roughly 20 pedestrians per hour, driver compliance decreases significantly. Thus, the base threshold for consideration of an enhanced crossing treatment at an uncontrolled location is 20 pedestrians per hour. This threshold is consistent with recent national guidance and policies adopted by other states and cities, as determined through literature research.

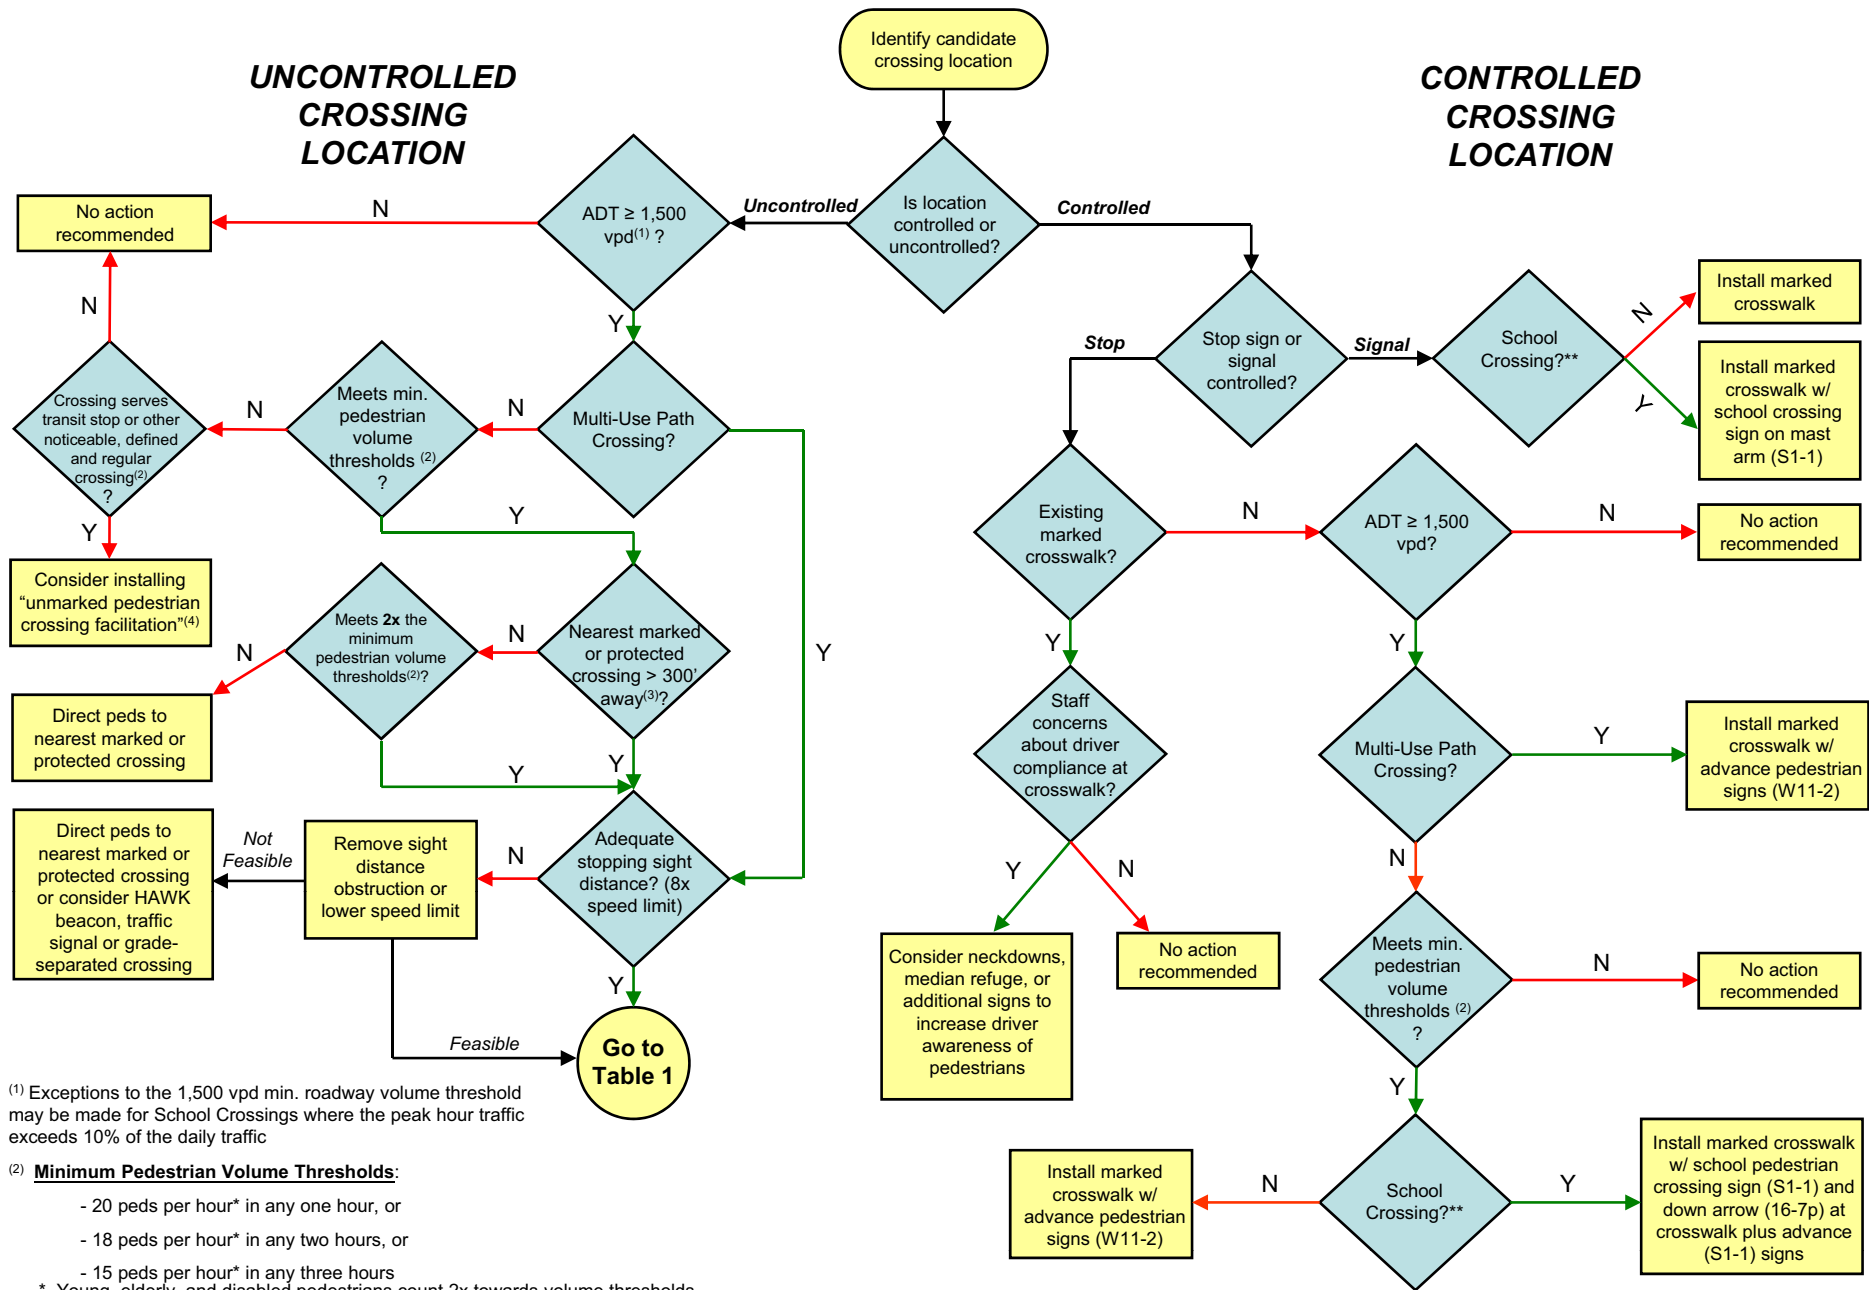
(1) Exceptions to the 1,500 vpd min. roadway volume threshold may be made for School Crossings where the peak hour traffic exceeds 10% of the daily traffic

(3) Distance to nearest marked or protected crossing may be reduced to 200' in urban conditions, subject to engineering judgment, where 1) the crosswalk does cross any auxiliary lanes, and 2) crossing treatments and crossing activity would not create undue restriction to vehicular traffic operations.

(4) An "unmarked pedestrian crossing facilitation" is any treatment that improves a pedestrian's ability to cross a roadway, short of the marked, signed and enhanced crossings detailed in Table 1. Installation of this type of pedestrian facilitation is subject to engineering judgment and may include curb ramps and/or a raised median refuge. However, no effort is made to attract pedestrians or recommend that pedestrians cross at this location. The treatments simply provide an improvement for a low volume pedestrian crossing where pedestrians are already crossing and will like continue to cross.

- a) Using the available data, utilize *Figure 1 – Pedestrian Crossing Treatment Flowchart* and *Table 1 – Criteria for Crossing Treatments at Uncontrolled Locations* (if applicable) to determine appropriate treatment(s) for signalized, stop-controlled, or uncontrolled locations. Also consider and incorporate the information in Section 2.2 and in Figure 2 as appropriate.

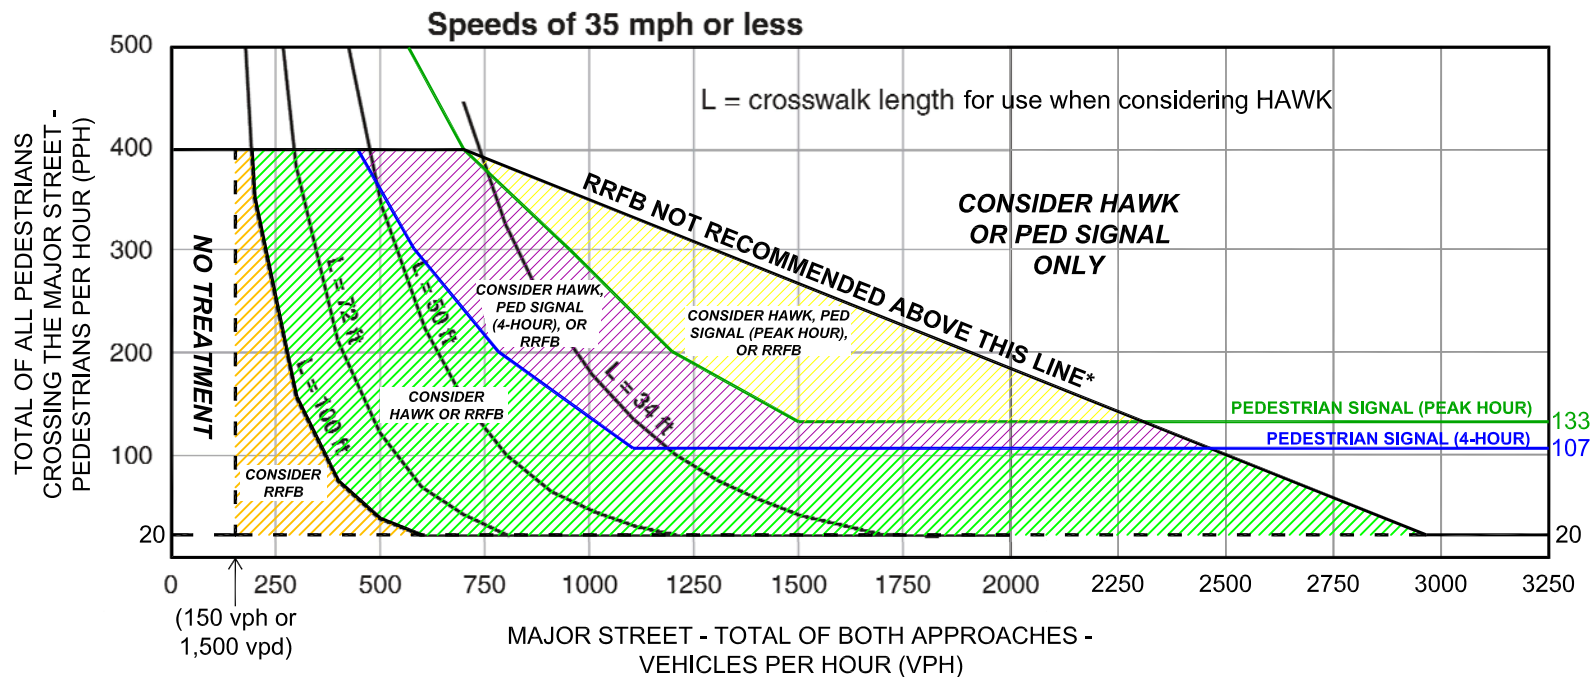
**Figure 2a. City of Boulder Guidelines for the Installation of Pedestrian Hybrid (HAWK) Beacons, Pedestrian Signals, or Rectangular Rapid Flash Beacon (RRFB) Signs on Low-Speed Roadways**

\* RECOMMENDATION BASED ON CITY OF BOULDER SAFETY EVALUATIONS AT EXISTING RRFB SITES AND OBSERVED IMPACTS TO VEHICULAR TRAFFIC OPERATIONS

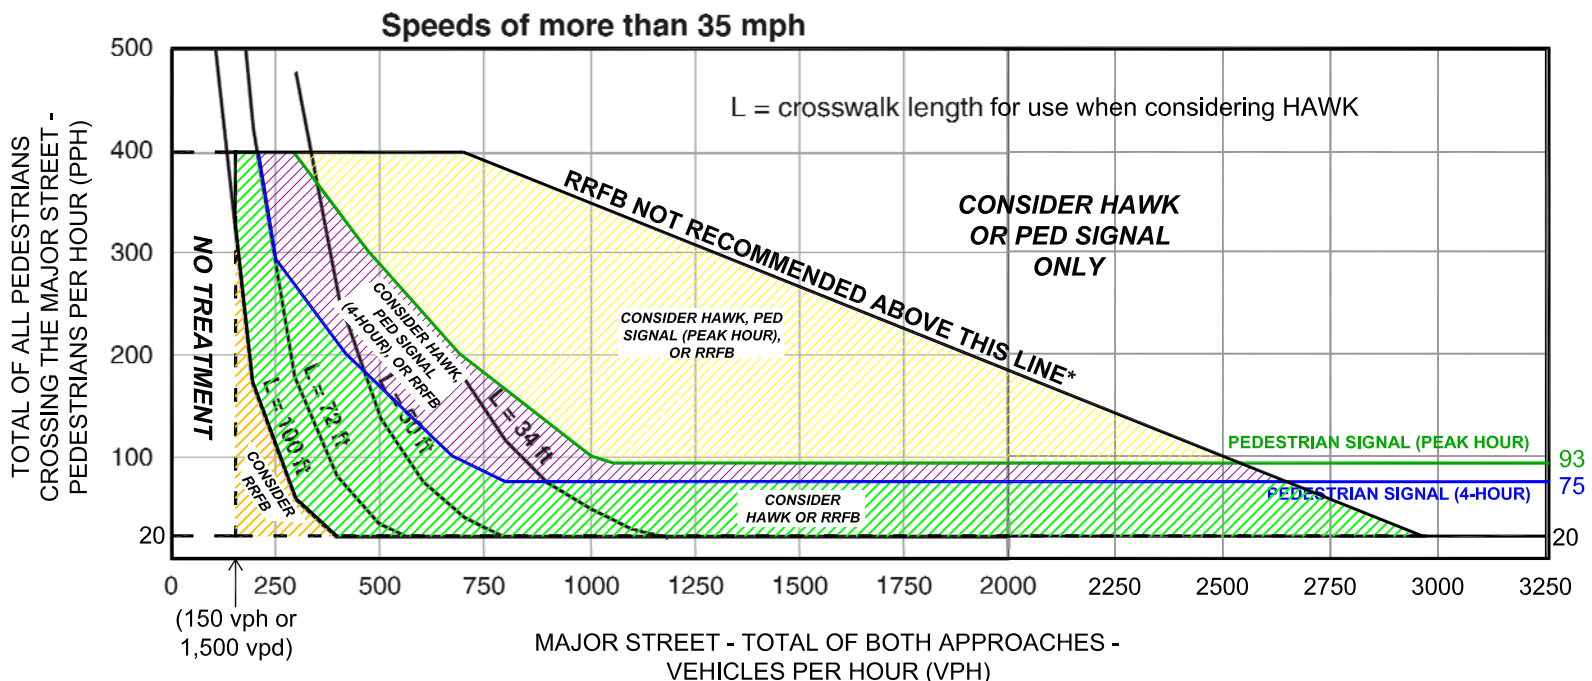
**Figure 2b. City of Boulder Guidelines for the Installation of Pedestrian Hybrid (HAWK) Beacons, Pedestrian Signals, or Rectangular Rapid Flash Beacon (RRFB) Signs on High-Speed Roadways**

\* RECOMMENDATION BASED ON CITY OF BOULDER SAFETY EVALUATIONS AT EXISTING RRFB SITES AND OBSERVED IMPACTS TO VEHICULAR TRAFFIC OPERATIONS
